News & Facts

March 2014

Usual causes of Winkhaus locks being broken

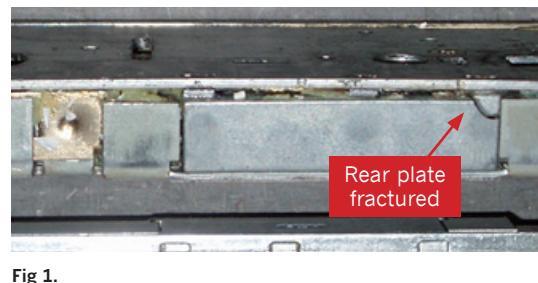
This type of break can be identified by looking at the rear of the gearbox. When the gearbox bursts the rear plate will be pushed apart (Fig 1). In more severe cases gearbox components will push out of the gearbox completely (Fig 2). This failure is seen when a door has been closed and locked then the handle is forced in attempted entry i.e. burglary attempt.

Burst Gearbox

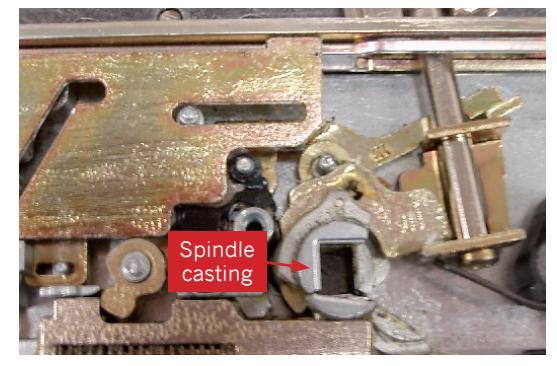
Fig 3.

A spindle casting failure can be identified when the casting breaks (Fig 3). This failure is seen when a door has been closed and locked then the handle is forced in attempted entry i.e. burglary attempt.

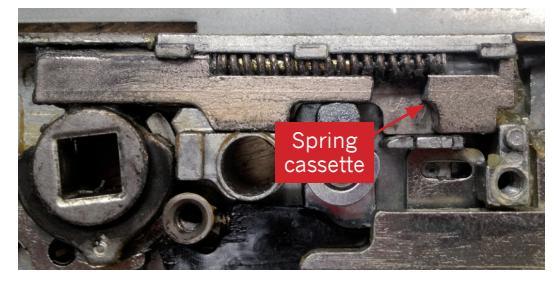
Fig 4.

This component (Fig 4) provides the spring in the handles when throwing hooks. They can break if the loads needed to throw the hooks are significantly increased. The most common cause of this problem is fitting/installation. If the keeps are not properly adjusted, the door drops or the air gap is incorrect the hooks barb or rub against the keeps increasing the loads required to fully throw the hooks and enable locking. Where this fault occurs the door installation should be checked.

As this component is not visible, identification can be established when lifting the handles to throw the hooks. The handle will lift but the hooks do not throw.

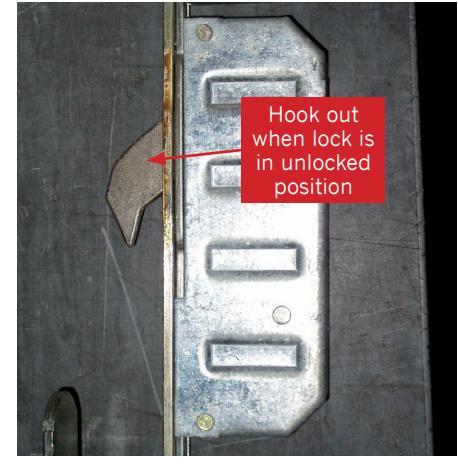
Fig 5.

This problem can be seen when one hook is out (Fig 5), when the deadbolt and other hook(s) are in the unlocked position. The lock will then not lock fully as the hook jams the mechanism. There can be many reasons for this to occur including door installation, transport, handling and storage.

On Trulock[™] this issue is not seen, as a rack and pinion system is used on the hook mechanism. On Cobra[™] and Thunderbolt[™] there are now two driving tabs in place instead of the original one.

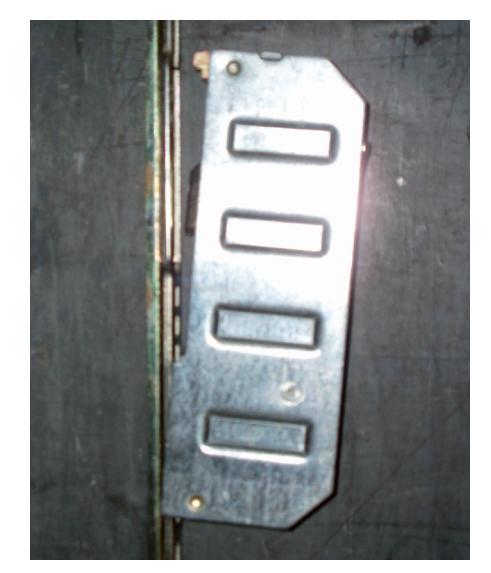
Fig 6.

The hook and gearbox are held in position by two rivets which go through a casting on the rail to hold it in position. This casting can snap causing the hook box to push away from the rail as shown to the right (Fig 6). It has been determined that the cause of the "snapping" is transit damage, especially where doors have not been packed correctly between sash and frame. In addition Winkhaus have changed our packaging method and the casting now has a steel pin running through it which will provide more resistance to fracturing.
